Cape May Promenade

Master Plan & Preliminary Visioning

October 25, 2023

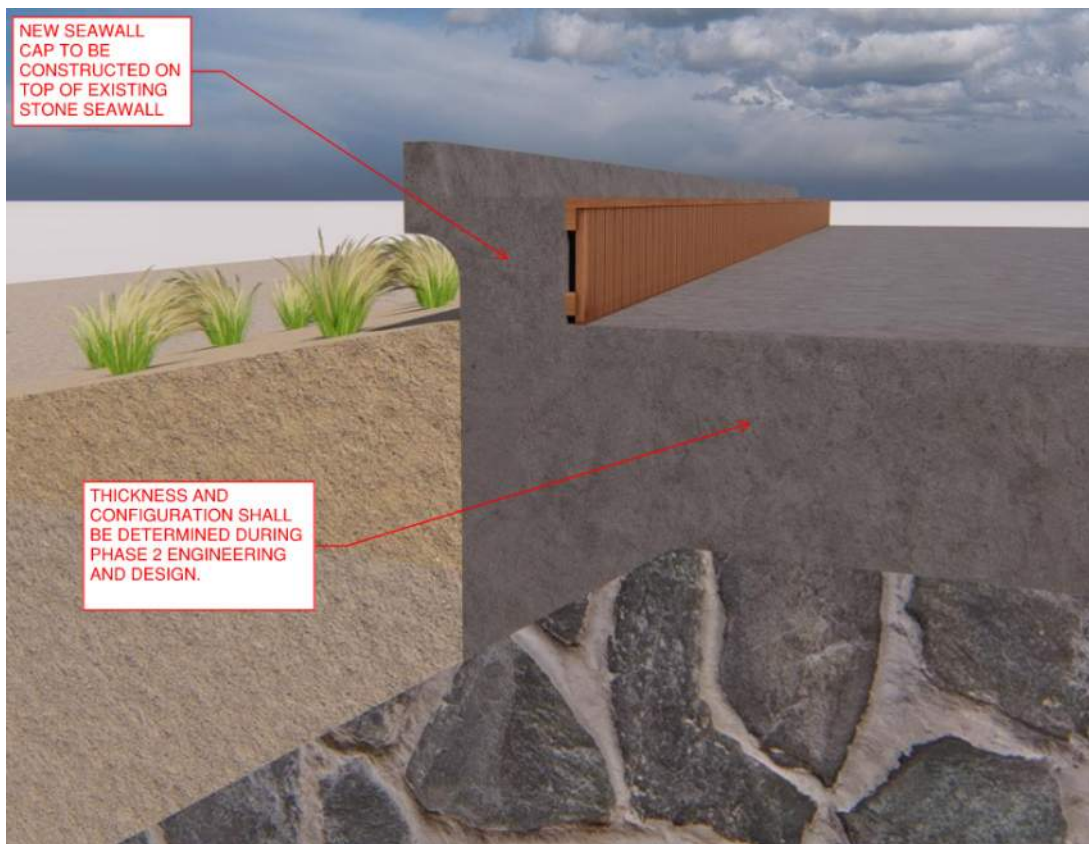
Promenade height extension cap to increase storm protection and resilience of the promenade

Furthermore, we propose the construction of a sitting/seawall extension along the south side of the remaining Promenade sections, starting from the area between Philadelphia Avenue and Madison Avenue and continuing along the entire Promenade to the West-End. This seawall height extension will increase the existing seawall height by approximately 2'-2", thereby elevating the flood protection level from an average of +10.5 NAVD88 to approximately +12.65 NAVD88. This extension will be constructed atop the existing stone seawall that runs along the south side of the Promenade. Notably, this design will harmoniously integrate with the seawall proposed for the East-End of the city, and it will also serve as a multifunctional sitting wall, unifying the coastal area of Cape May City. See below for a photorealistic rendering of the proposed seawall height extension cap.

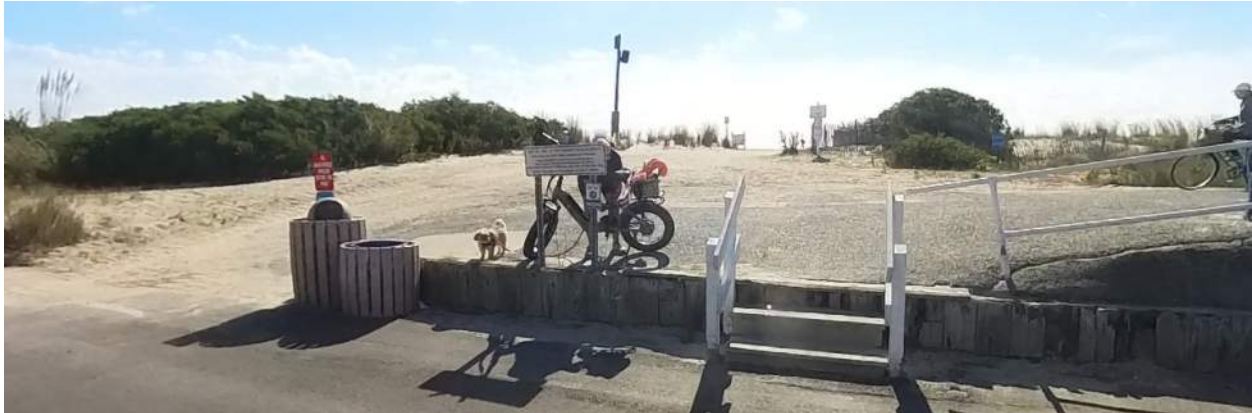
#1 – Promenade East End – Overall Grade (D)

This access point represents the farthest eastern reach of the current Cape May Promenade. It serves as a shared area for both pedestrians and City vehicles utilized for beach-related municipal tasks. However, the pedestrian access at this point falls significantly short of meeting ADA standards.

The current timber retaining wall is in a state of disrepair. The wall then transitions to a concrete retaining wall, which is in poor condition and exhibits signs of concrete spalling, cracking, and efflorescence.

- To enhance the promenade's storm resiliency, we propose the construction of an extended seawall/sitting wall along the southern edge, safeguarding the promenade and its surrounding infrastructure.
- Our plan involves implementing a concrete repair program for the existing concrete wall along Beach Avenue. This program will comprehensively address concrete spalling and cracking issues while applying a protective concrete coating to ensure the promenade's longevity and structural integrity.

- In line with our commitment to inclusivity, we recommend the addition of a new ADA-compliant access ramp. This addition will ensure that individuals with disabilities have equal access to the promenade, making it an inclusive and accessible destination.
- To maintain the promenade's functionality for essential beach-related operations, we emphasize the need for the continued operation and resilience of the vehicular access, contributing to the preservation of vital functions and services along the promenade.

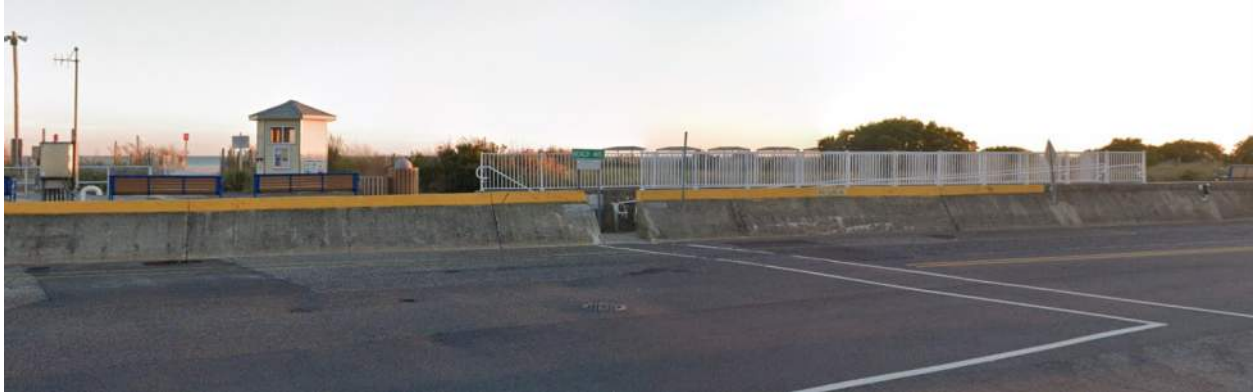
#2 - Madison Avenue – Overall Grade (D)

This access point serves as the initial ADA-compliant entry on the promenade, featuring a concrete ADA ramp and concrete steps leading to the promenade level.

The current concrete wall exhibits significant signs of wear and deterioration, characterized by prevalent concrete spalling and cracking.

This access point features an ADA access ramp and a durable timber decking surface leading to the beach. However, there are potential tripping hazards at the top of the ADA ramp. Additionally, the stairs lack a railing and guardrail on the street side of the stairs, which can pose safety concerns.

- We recommend repairing the concrete retaining wall along Beach Avenue in a manner similar to what was previously mentioned.

- Additionally, we propose enhancing the top transition from the ADA ramp to the promenade to eliminate the tripping hazards identified.
- Repair existing concrete ADA ramp.

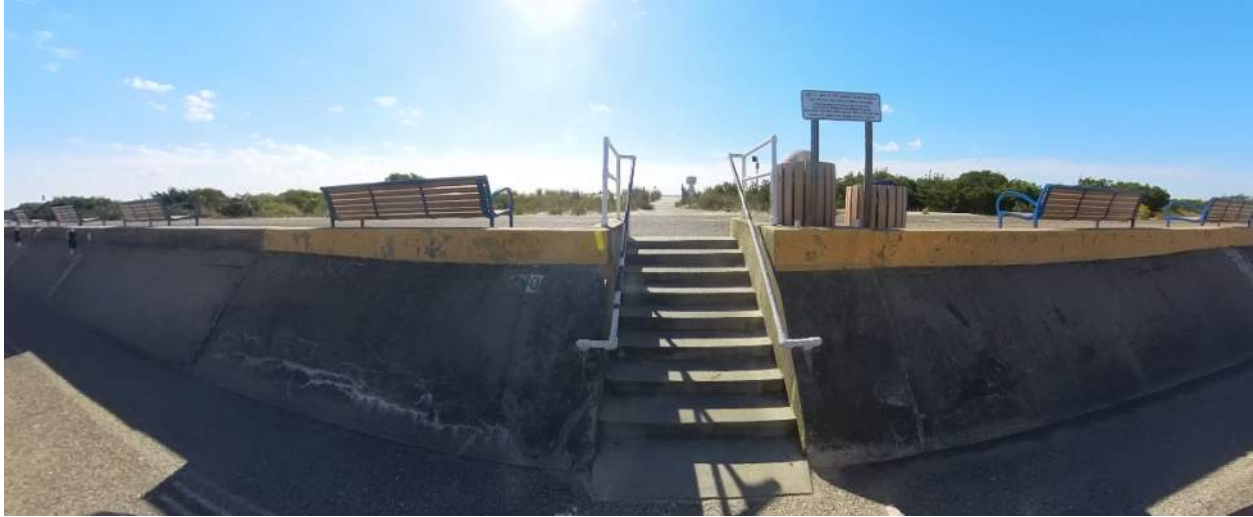
#3 – Queens Street – Overall Grade (D)

This access point solely features a staircase for entry. It is equipped with trash receptacles and provides access to the beach, although it lacks a rinse station.

The existing concrete wall is in poor to fair condition. It has concrete spalling and cracking in areas.

- We recommend repairing and coating the concrete retaining wall along Beach Avenue in a manner similar to what was previously mentioned.

- Construct a new ADA access ramp.

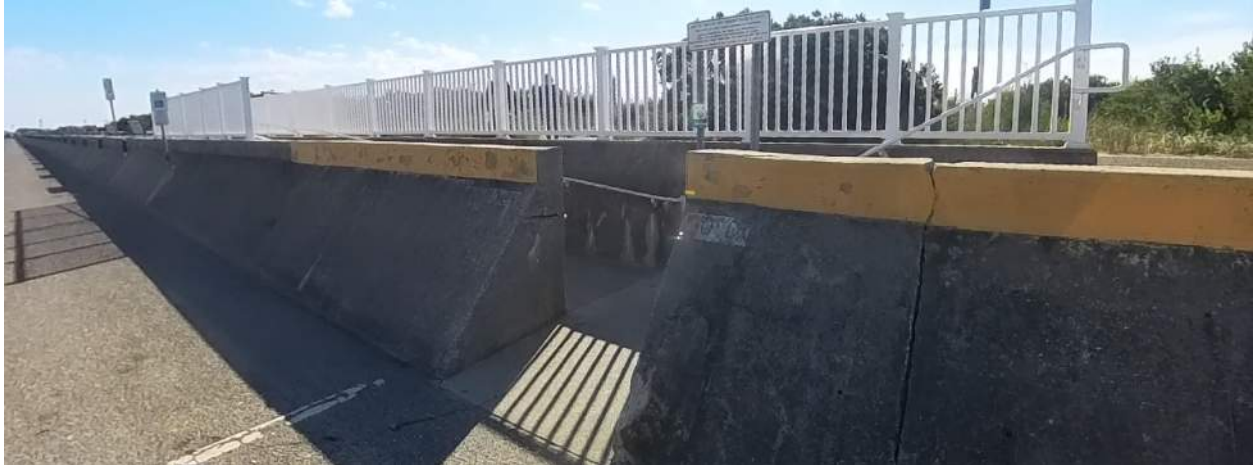
#4 – Jefferson Street – Overall Grade (D)

This access point has stairs and a ramp. It has similar concrete deterioration.

The existing concrete wall is in poor to fair condition. It has exposed rebar, concrete spalling and cracking in areas.

This access point has an ADA ramp, but it is in poor condition and need repairs.

- Concrete repairs and coating of the wall along Beach Avenue.
- Promenade walking surface resurfacing.
- Repair existing concrete ADA ramp.

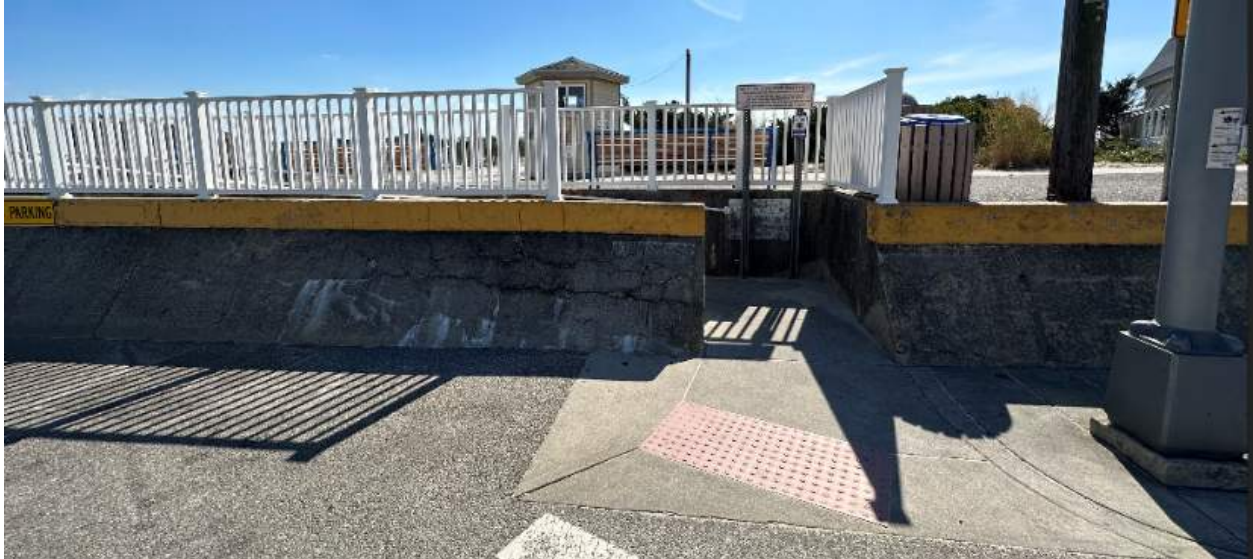
#5 – Howard Street – Overall Grade (D)

This access point has a concrete ramp from the street level up onto the promenade. The concrete is in poor condition.

The existing concrete wall is in poor to fair condition. It has exposed rebar, concrete spalling and cracking in areas.

This access point has an ADA ramp, but it is in poor condition and need repairs.

- Concrete repairs and coating of the wall along Beach Avenue.
- Promenade walking surface resurfacing.
- Repair existing concrete ADA ramp.

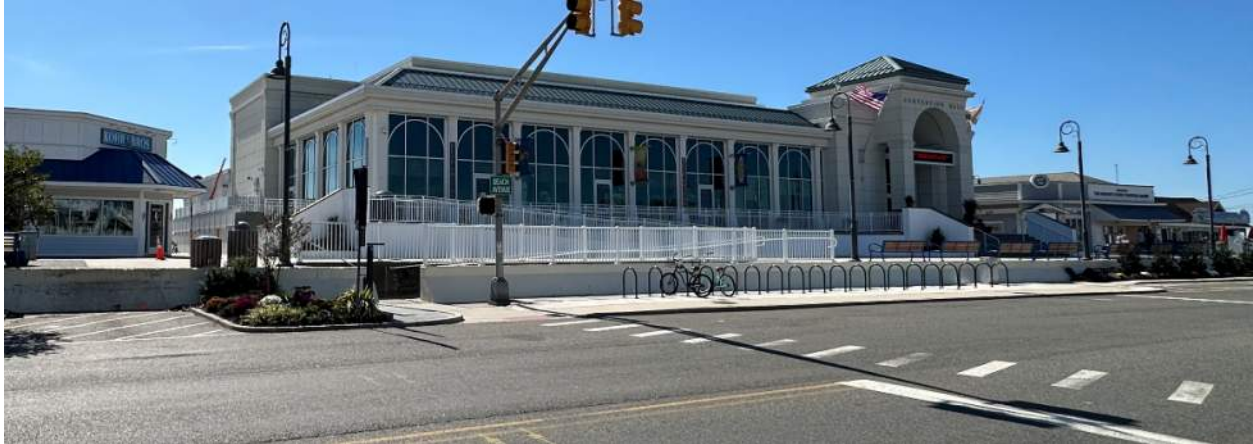
#6 – Stockton Place – Overall Grade (A)

This is the main access point for the Cape May Convention Hall. It appears some concrete repairs and coating have been carried out in this location. These are also good amenities like protected bike racks, a bike repair station, ADA access, good lighting etc. We propose to use this access point as the template for the other access points along the promenade.

The existing concrete wall is in good condition and has been coated to increase lifespan of the wall and improve the overall aesthetics.

This access point has an ADA ramp, and it is in good condition.

- Recoat wall as needed.
- Repair existing concrete ADA ramp.

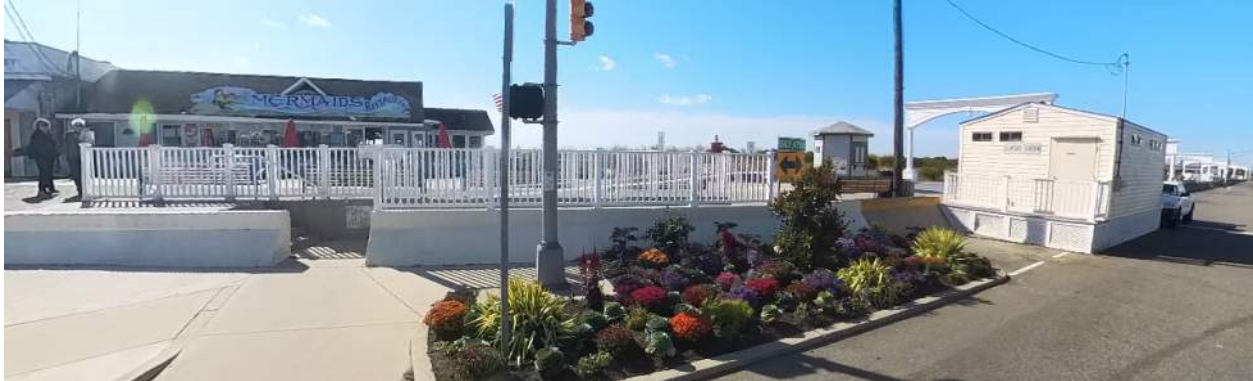
#7 – Gurney Street – Overall Grade (B)

Portions of the concrete wall in this area have been repaired and coated, others have been left in their existing deteriorated condition. This access point has steps and a ramp that are in need of concrete repairs. There is a comfort station that is in fair condition.

The existing concrete wall is in good condition. Portions still need repairs and a protective coating.

This access point has an ADA ramp. It is in good condition and needs only minor repairs.

- Concrete repairs and coating of the wall along Beach Avenue.
- Promenade walking surface resurfacing.
- Comfort station rehab and wet floodproofing.
- Repair existing concrete ADA ramp.

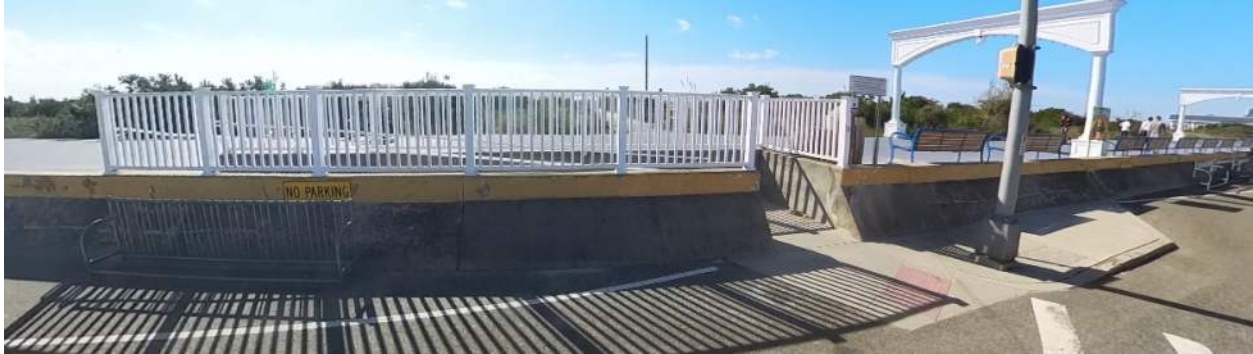
#8 – Ocean Street – Overall Grade (B)

Overall, the Ocean Street access point is in good condition. The promenade walking surface has been redone recently. This area needs minor repairs and a protective coating.

The existing concrete wall is in good condition, needs minor repairs and a protective coating.

This access point has an ADA ramp, it is in good condition.

- Concrete repairs and coating of the wall along Beach Avenue.
- Repair existing concrete ADA ramp.

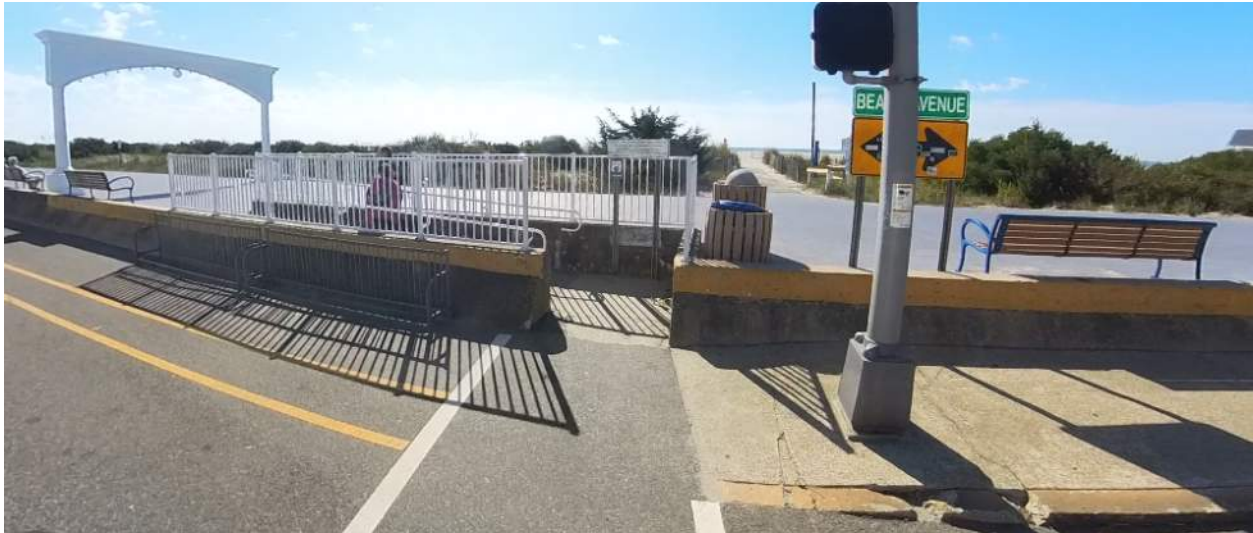
#9 – Decatur Street – Overall Grade (C)

At this access point, there is a ramp leading up to the promenade. Notably, the concrete wall in this vicinity seems to be in better condition. While minor concrete repairs are still required, the level of deterioration observed here is notably lower when compared to the East End.

The existing concrete wall is in fair condition, needs minor repairs and a protective coating.

This access point has an ADA ramp that is in fair condition.

- Concrete repairs and coating of the wall along Beach Avenue.
- Repair existing concrete ADA ramp.

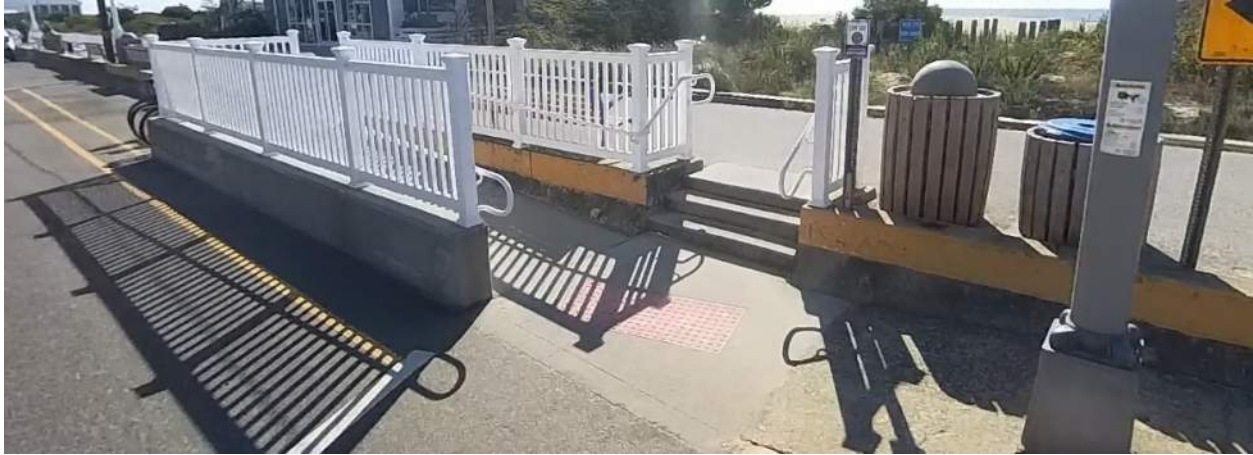
#10 – Jackson Street – Overall Grade (B)

Just before reaching this access point, the promenade experiences a narrowing after the Beach Arcade building. Here, a new ADA ramp is installed and is in excellent condition. Given the limited space available on the promenade, this ramp extends into the street, occupying the width of the parking stalls along Beach Avenue.

Here, the promenade configuration changes. The existing stone seawall on the South side of the promenade ends right after the Beach Arcade on the West Side. A timber bulkhead takes the seawalls place along the South Side of the promenade to protect the City and create the promenade walking surface. This timber bulkhead is in poor to failing condition and needs replacement.

The existing concrete wall is in fair condition, needs minor repairs and a protective coating.

This access point has an ADA ramp that is in excellent condition.

- Concrete repairs and coating of the wall along Beach Avenue.
- It is at this location that we proposed to begin the promenade widening and the steel bulkhead seawall installation portion of the preservation project.
- Resurface promenade walking surface and apply coating.

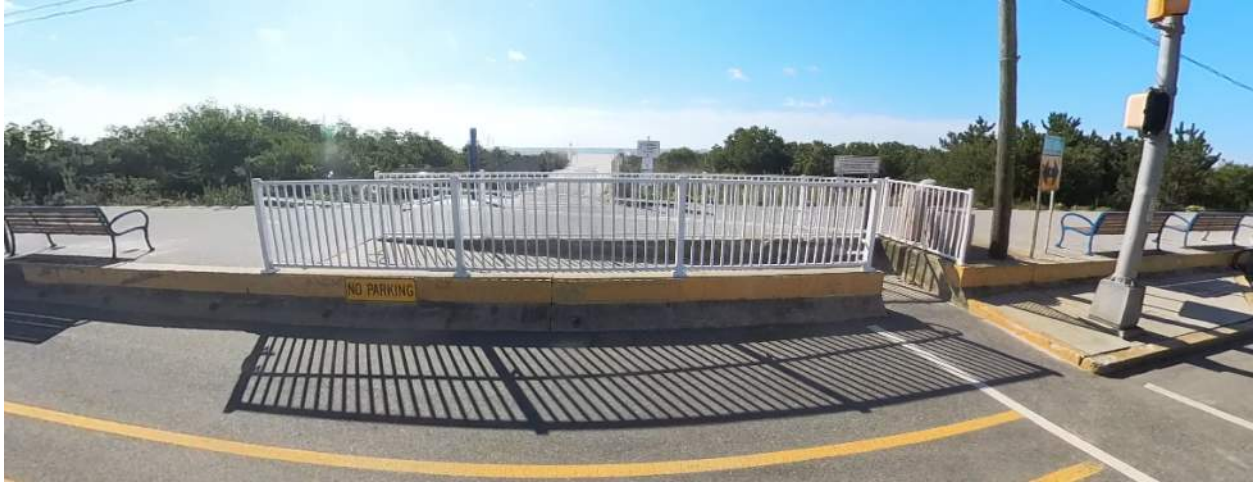
#11 – Perry Street – Overall Grade (C)

This access point exemplifies a primary challenge with the width of the promenade in this segment. An existing ramp extends into the promenade's width, significantly narrowing it. These areas have been prone to issues between bikers and pedestrians using the promenade.

The existing concrete wall is in fair condition, needs minor repairs and a protective coating.

The existing walls of the concrete ramp are in poor condition and need repairs and coating.

The proposed widening project will address this concern. This widening effort aims to enhance the usability of the promenade in these specific areas. Additionally, it will entail the replacement of the deteriorating timber bulkhead seawall with a new steel bulkhead seawall, raising the level of storm protection for the City of Cape May.

- Concrete repairs and coating of the wall along Beach Avenue.
- Continue the promenade widening and the steel bulkhead seawall installation.
- Resurface promenade walking surface and apply coating.
- Repair existing concrete ADA ramp.

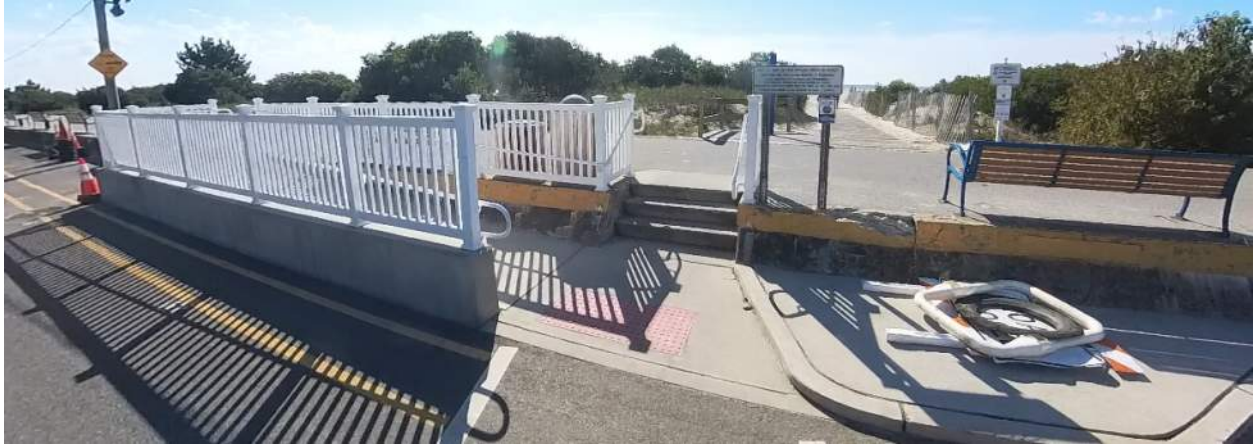
#12 – Congress Street – Overall Grade (C)

This access point has a new ADA ramp that extends into Beach Avenue.

The existing concrete wall is in poor condition with large concrete spalling and cracking.

The ADA ramp is new and in excellent condition.

- Concrete repairs and coating of the wall along Beach Avenue.

- Continue the promenade widening and the steel bulkhead seawall installation.
- Resurface promenade walking surface and apply coating.

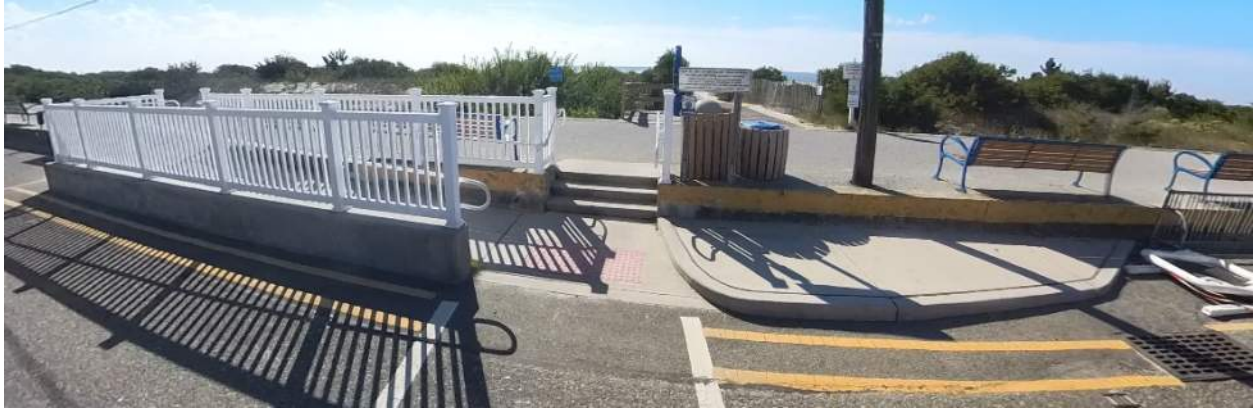
#13 – Windsor Avenue – Overall Grade (B)

This access point also has a new ADA ramp that extends into Beach Avenue.

The existing concrete wall is in good condition.

The ADA ramp is new and in excellent condition.

- Concrete repairs and coating of the wall along Beach Avenue.
- Continue the promenade widening and the steel bulkhead seawall installation.
- Resurface promenade walking surface and apply coating.

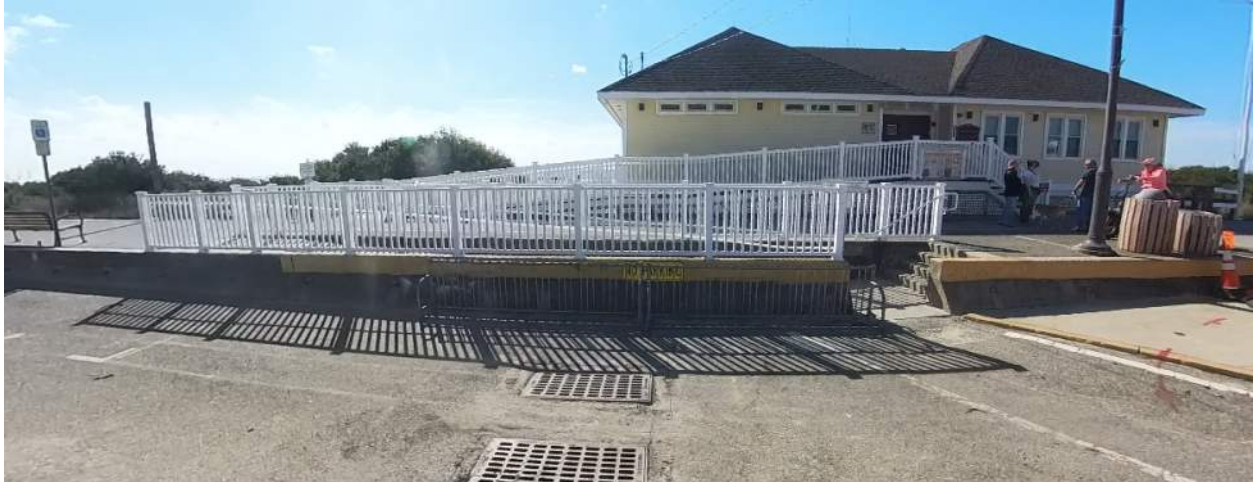
#14 – Grant Street – Overall Grade (C)

This access point has an existing concrete ramp and steps up onto the promenade. The Bike racks are in the street somewhat protected from traffic by the raised curb to the West.

The existing concrete wall is in fair condition with spalling and cracking in select areas.

The ADA ramp and steps are in fair condition.

- Concrete repairs and coating of the wall along Beach Avenue.
- Continue the promenade widening and the steel bulkhead seawall installation.
- Resurface promenade walking surface and apply coating.
- Repair existing concrete ADA ramp.

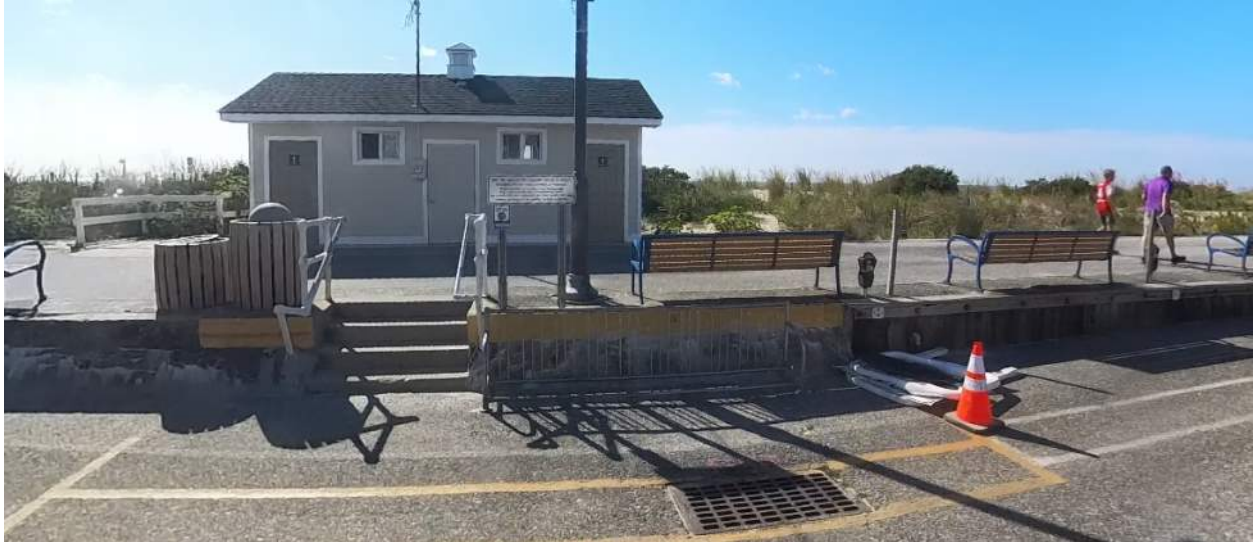
#15 – Grant Street Comfort Station – Overall Grade (D)

This access point has a comfort station and steps. The railings for the steps are notable not ADA compliant. It is at this location where the concrete wall along Beach Avenue turns into a timber bulkhead in poor to fair condition.

The comfort station is in fair condition, it appears to be below DFE and not properly flood proofed.

The existing concrete wall is in poor condition with spalling, efflorescence and cracking throughout.

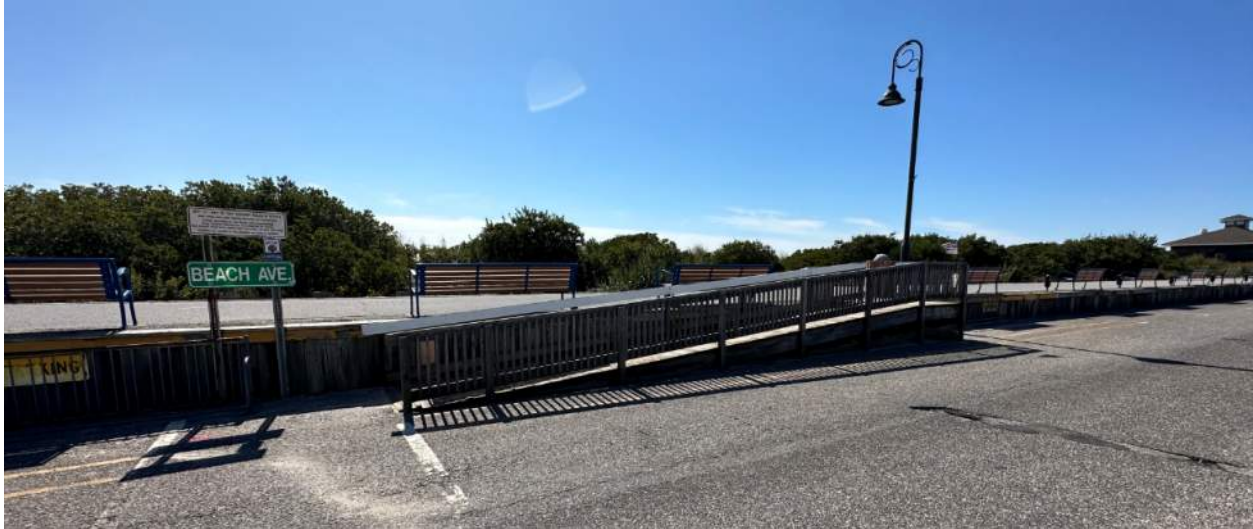
#16 – Patterson Avenue – Overall Grade (D)

This access point has a timber ramp in fair condition. The timber bulkhead continues through this section of the promenade.

The existing timber bulkhead along the road is in poor condition. It is missing planks and the top board is weathered and loose.

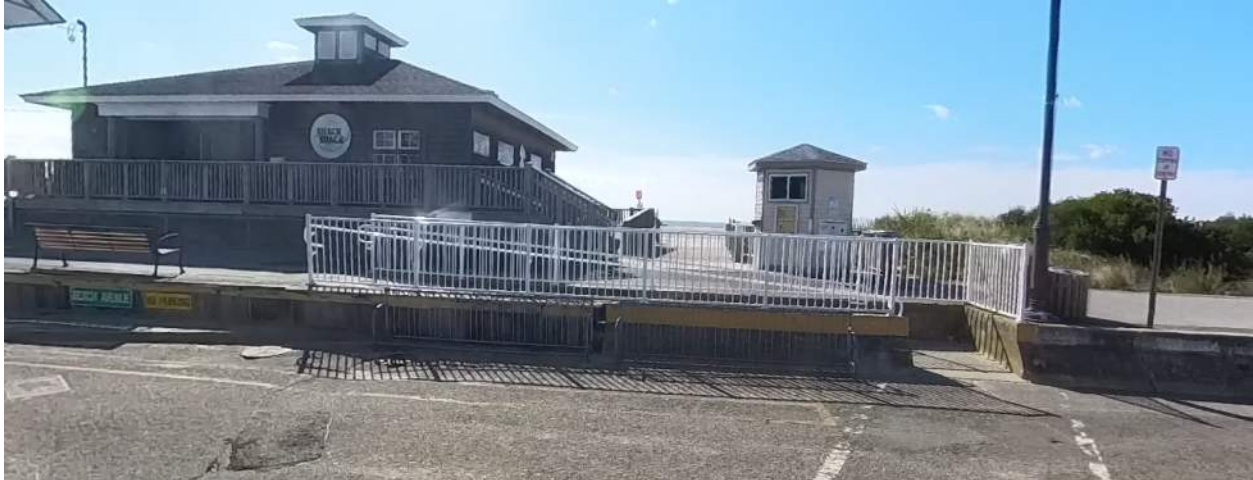
#17 – S. Broadway – Overall Grade (D)

The timber bulkhead along Beach Avenue transitions back to a concrete wall. This access point does a ramp, but it is in poor condition.

The concrete ramp is in fair condition and need concrete spall and crack repairs.

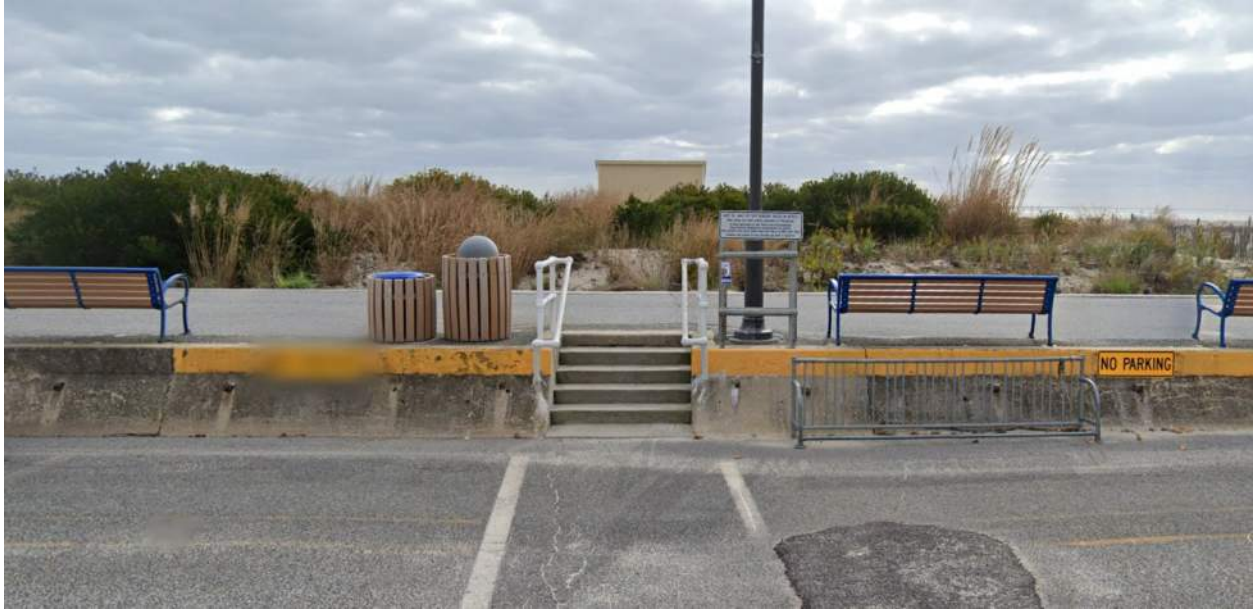
#18 – 1st Avenue – Overall Grade (C)

This access point does not have any ramps only steps up onto the promenade. The access point is in fair condition overall and needs similar repairs and preservation activities. We proposed to end the promenade widening and seawall height extension at the 1st Avenue beach entrance due to the location of the existing dune system.

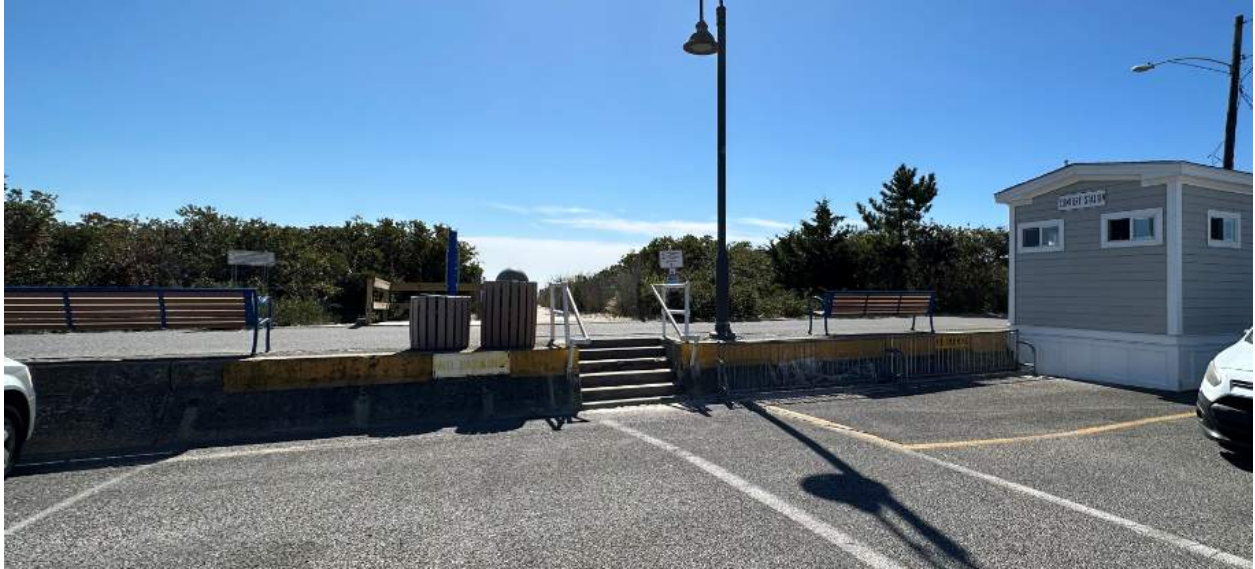
#19 – 2nd Avenue – Overall Grade (C)

This access point does not have any ramps only steps up onto the promenade. It does have a comfort station in fair condition.

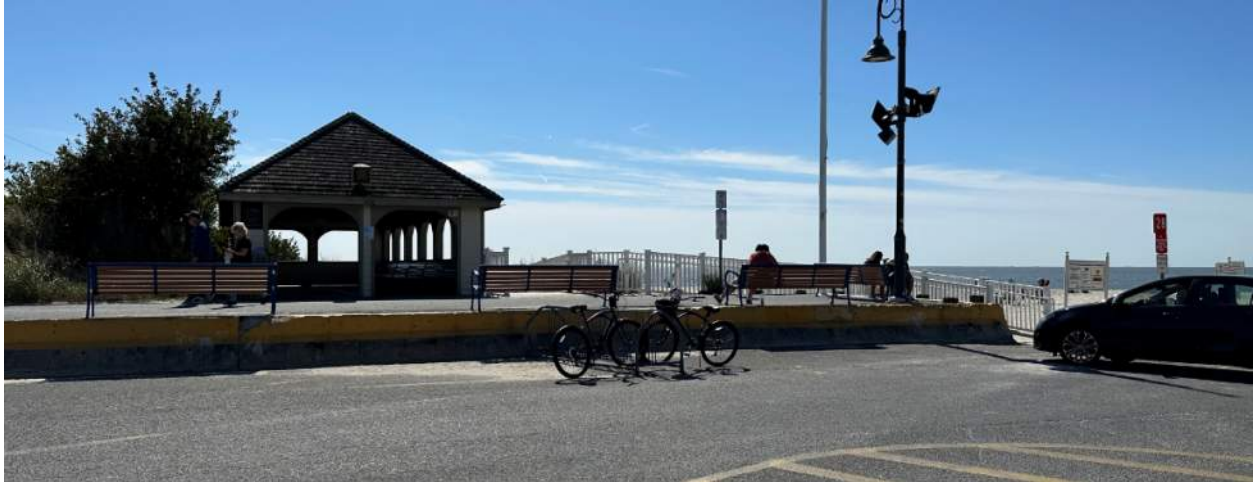
#20 – Cove Beach – Overall Grade (C)

This is the West end of the promenade. It has a newer ADA access ramp and a covered pavilion area.

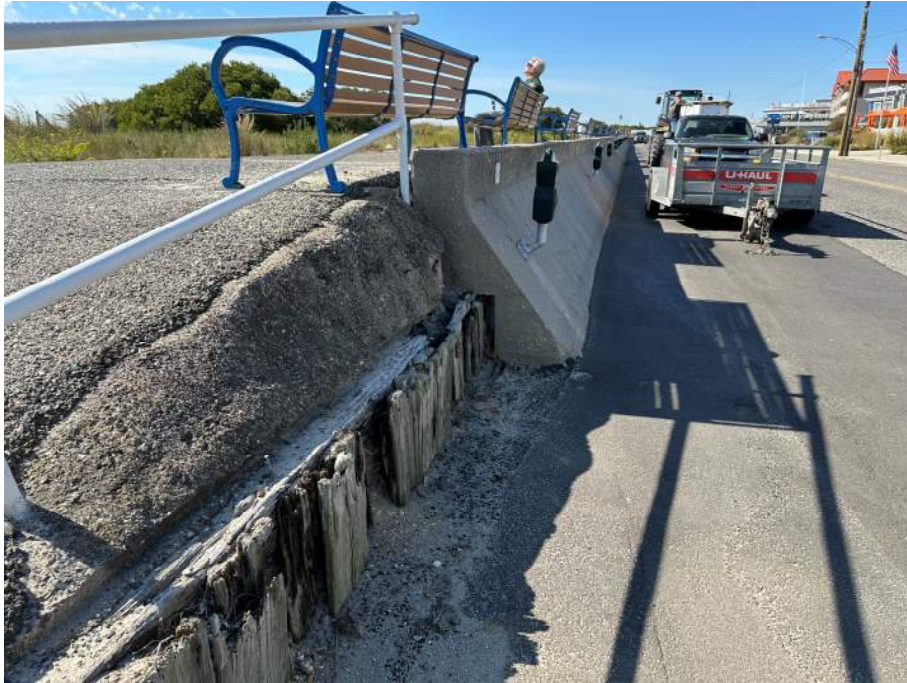
Photo #1 – Deteriorated timber bulkhead at Promenade East End.

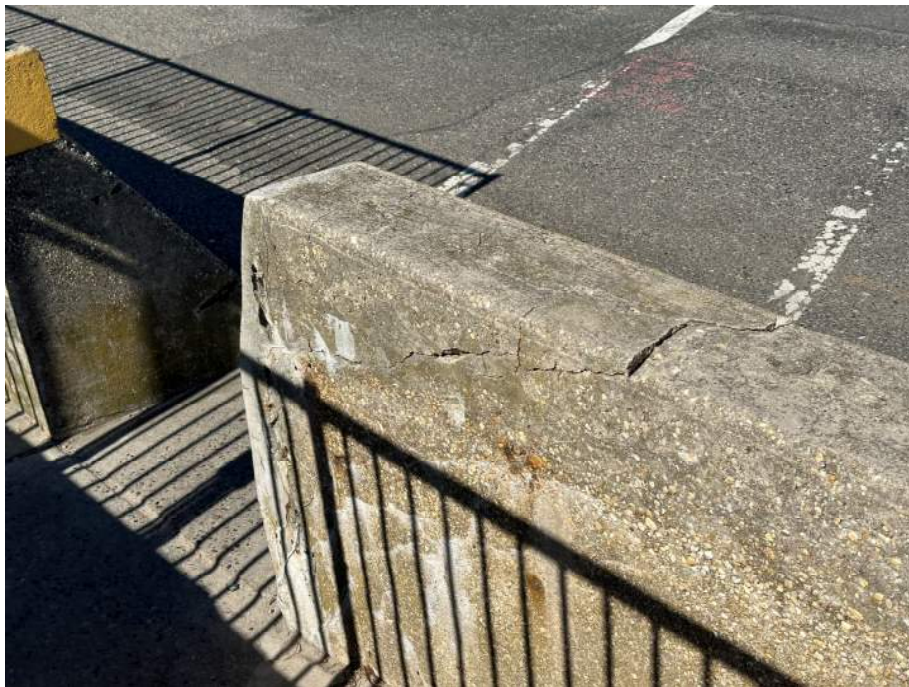
Photo #2 – Concrete deterioration on Madison Ave.

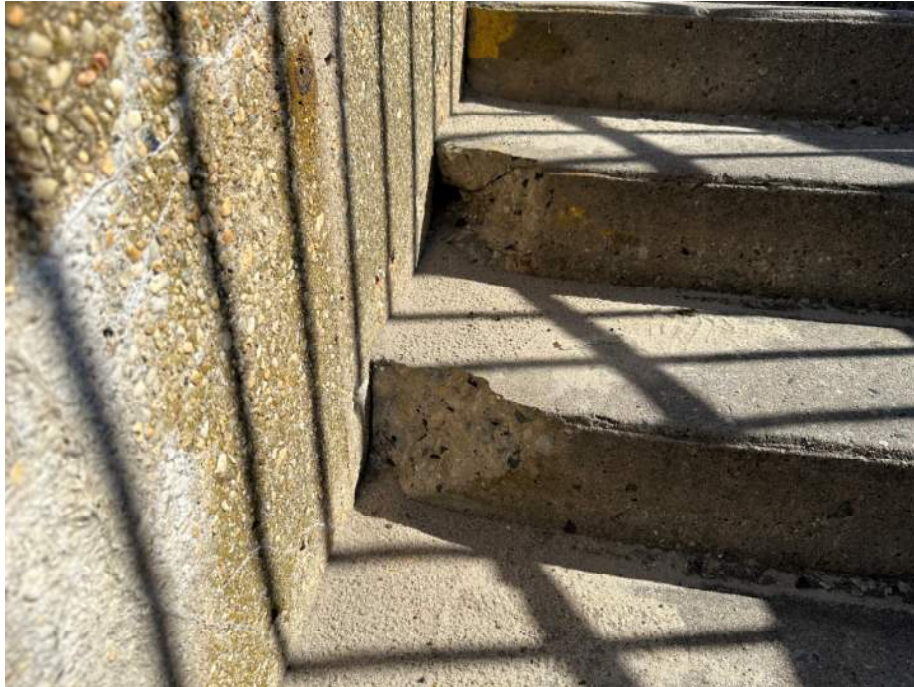
Photo #3 - Deteriorated concrete steps.

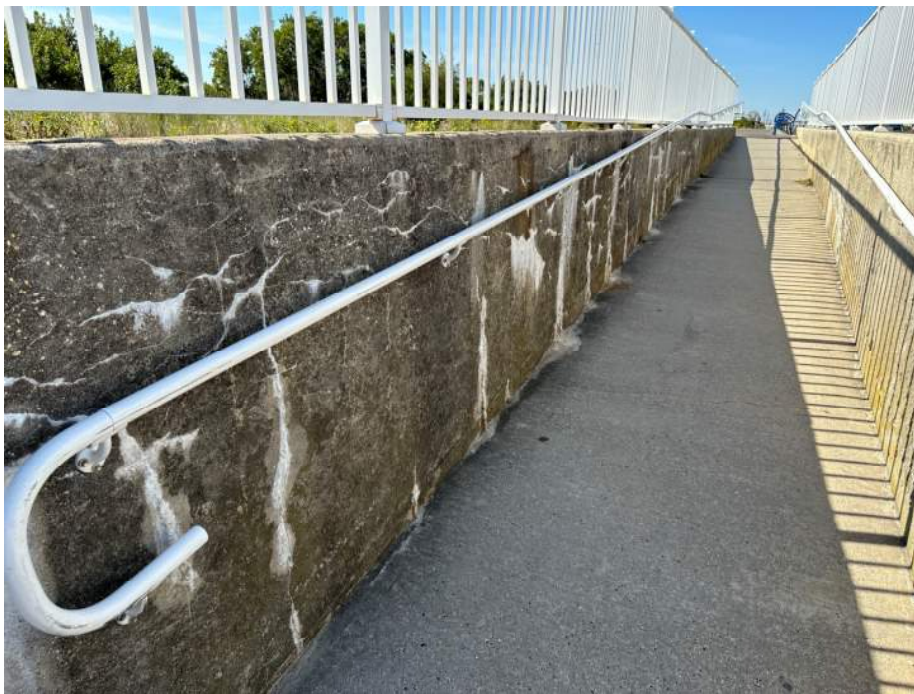
Photo #4 - Efflorescence on ramp walls.

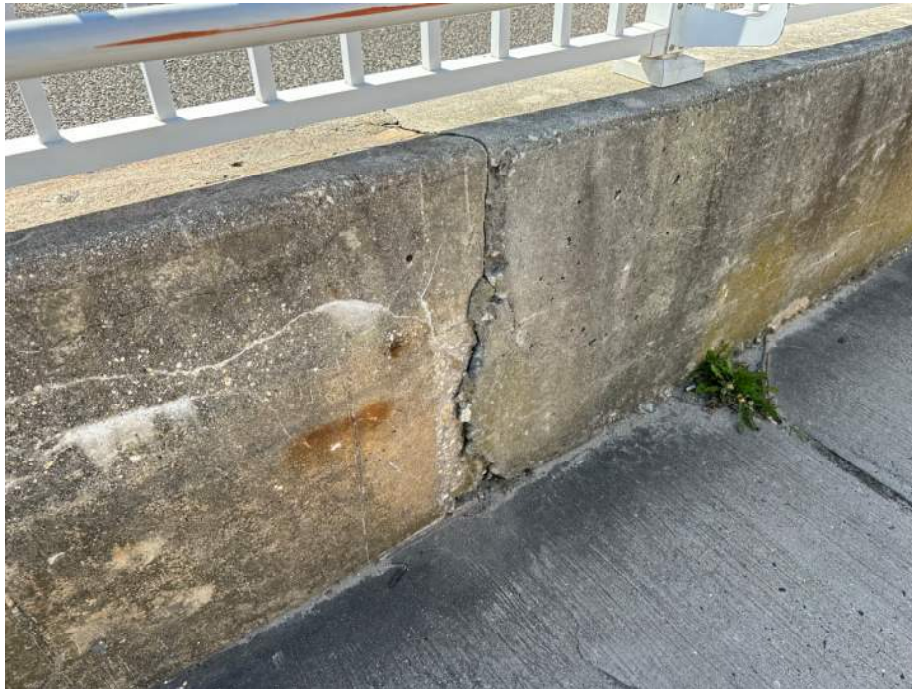
Photo #5 – Deteriorated concrete.

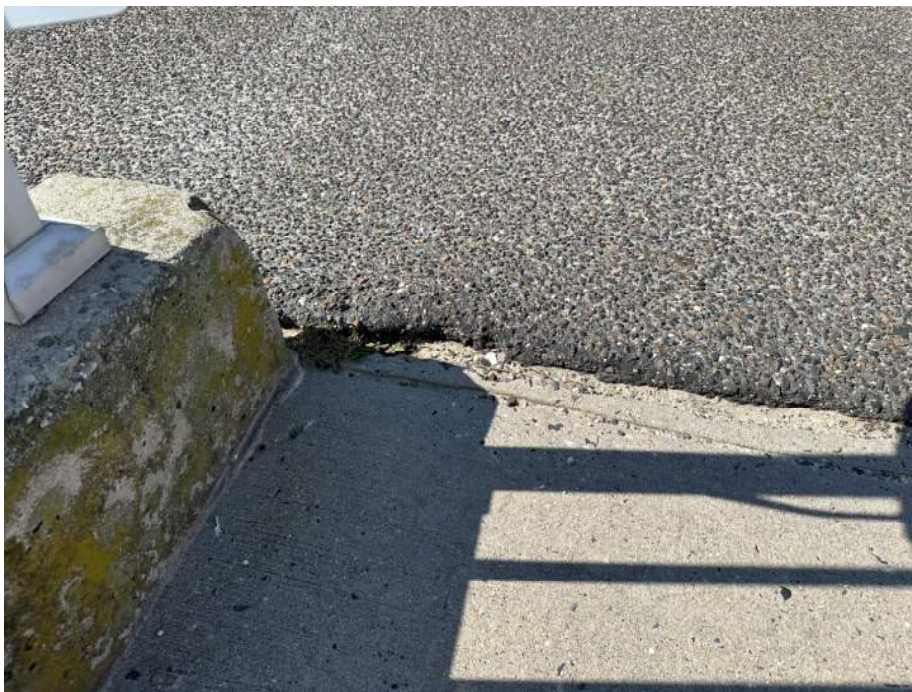
Photo #6 – Tripping hazard at top of ramp.

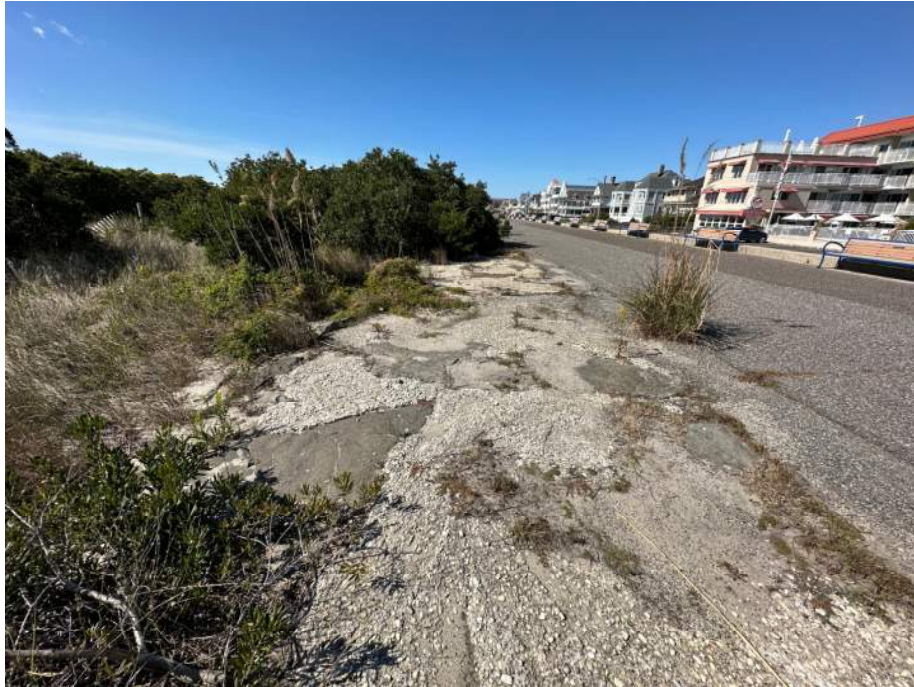
Photo #7 - Existing stone seawall running parralle to promenade.

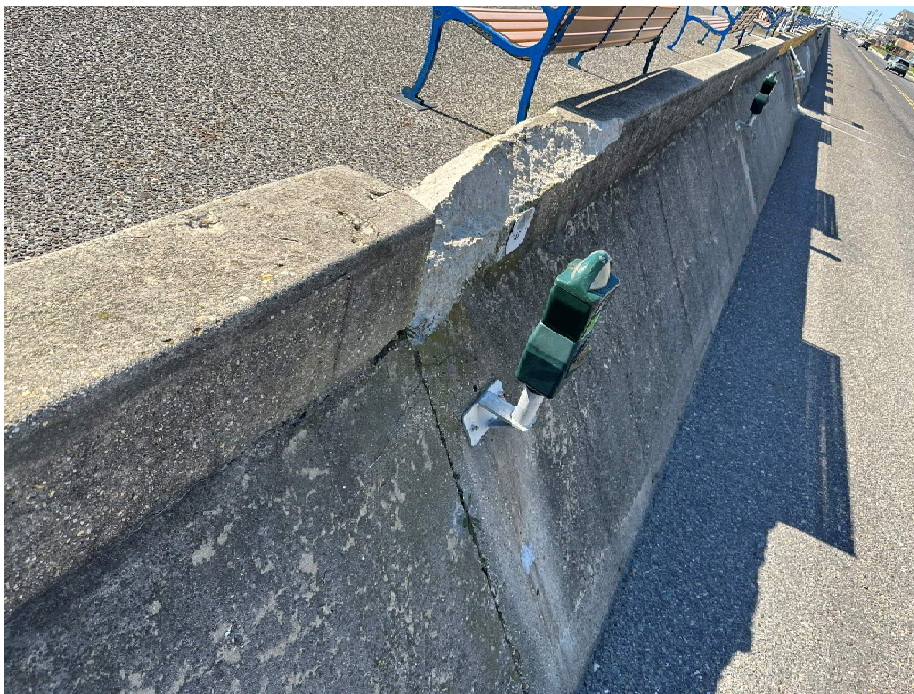
Photo #8 - Large concrete spall.

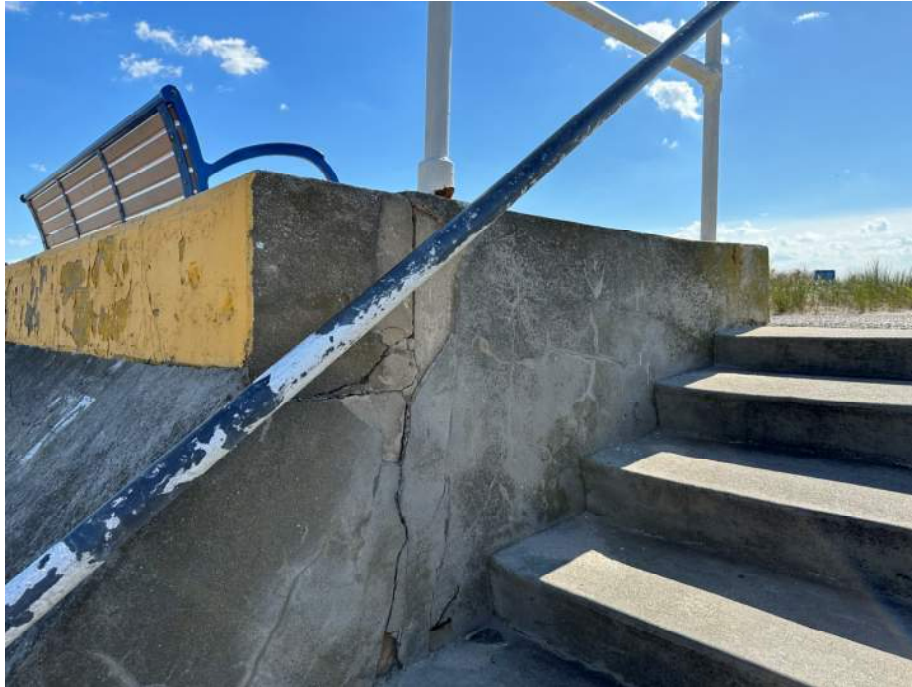
Photo #9 – Concrete cracking and delamination.

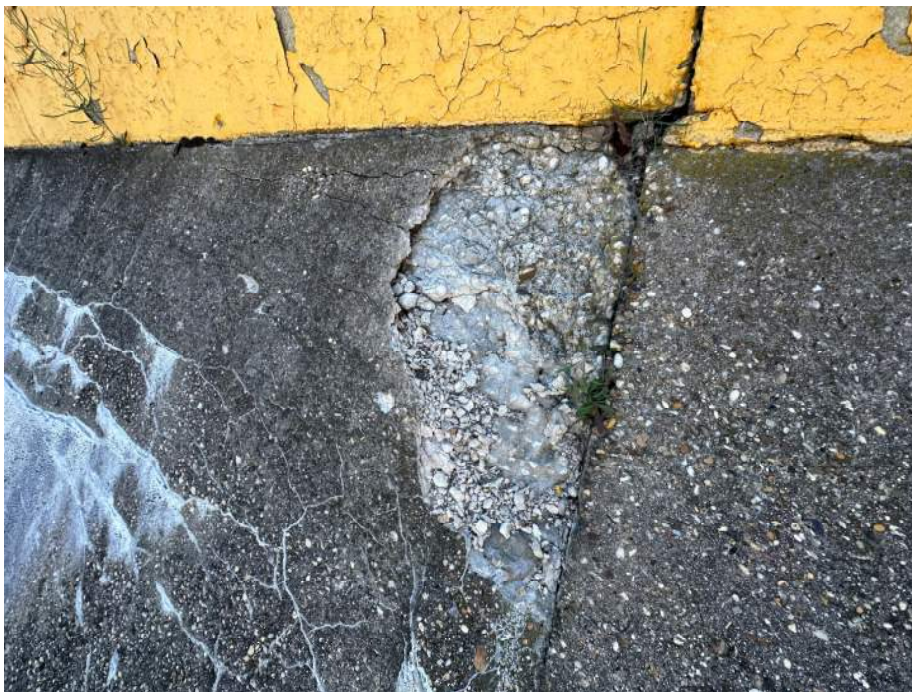
Photo #10 – Concrete cracking and delamination.
