Cape May Promenade

Master Plan & Preliminary Visioning

October 25, 2023

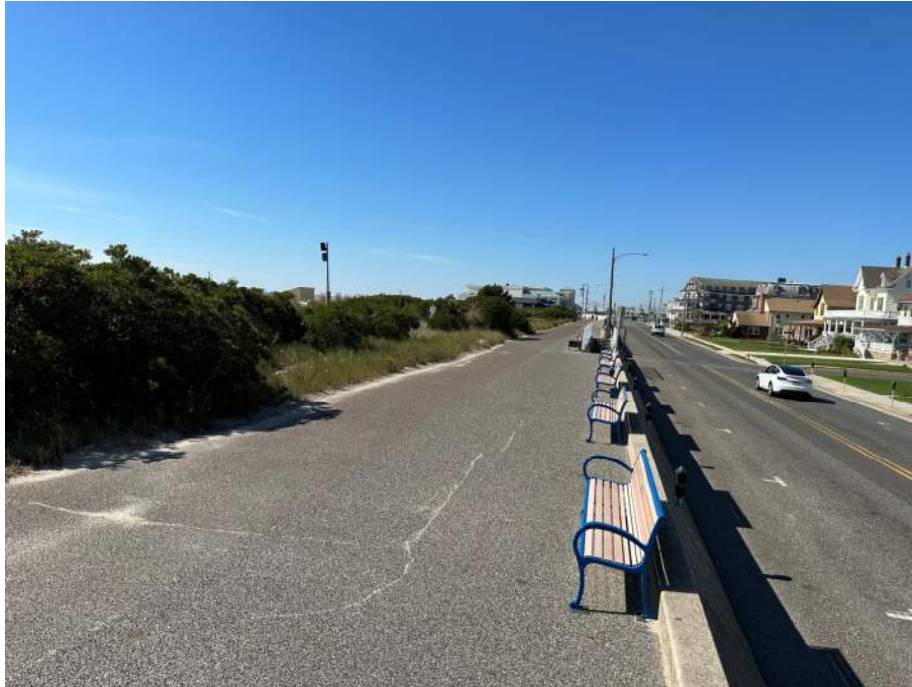
Photo #11 – Asphalt walking surface. Fair conditon.

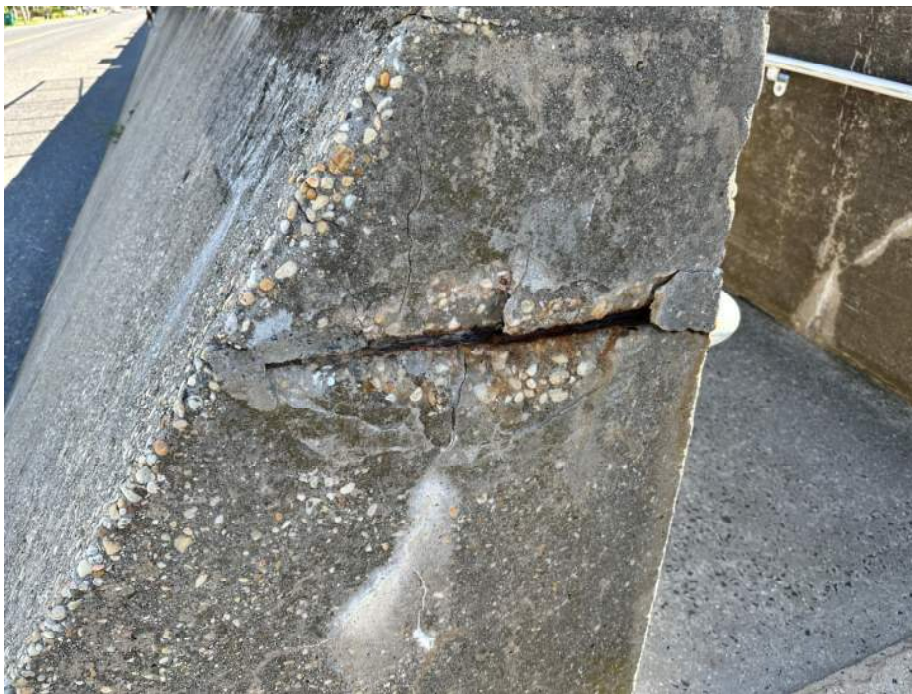
Photo #12 – Concrete spalling and exposed rebar.

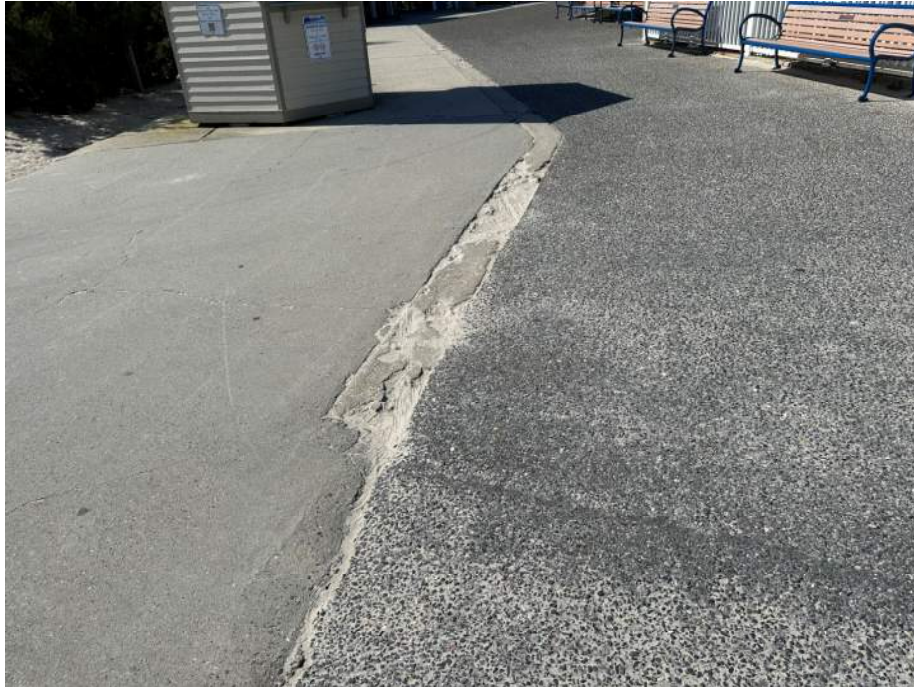
Photo #13 – Tripping hazards on promenade.

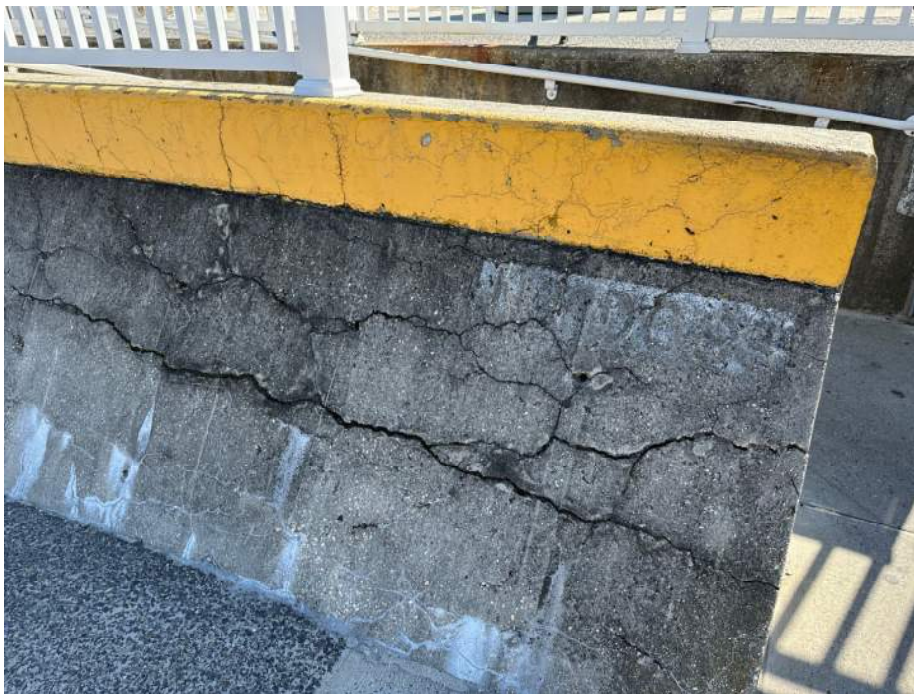
Photo #14 – Concrete cracking and delamination.

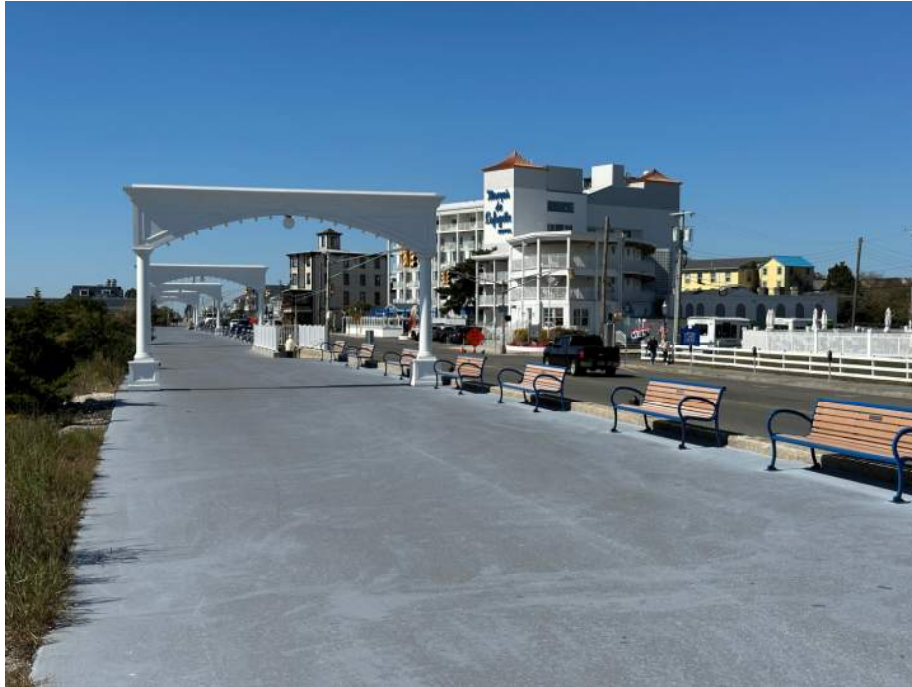
Photo #15 - Area where the promande walking surface has been redone.

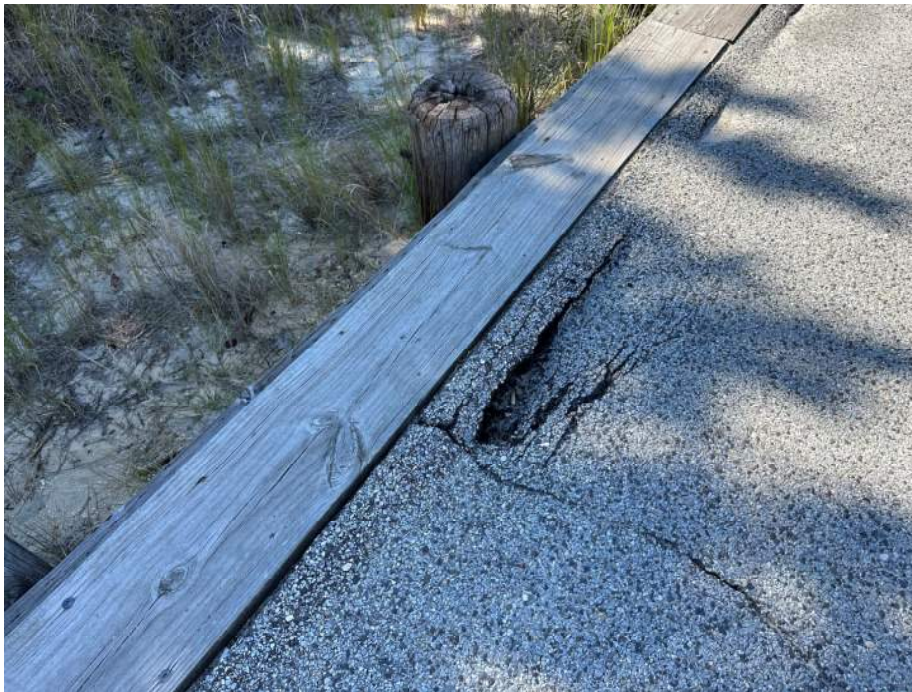
Photo #16 - Sinkhole formation behind failing timber bulkhead.

Widening of the promenade is specifically recommended between Jackson Street and 1st Avenue. It is our intention that the expansion in this area does not encroach upon the existing dune system. **This is a critical consideration, as the existing timber bulkhead on the south side of the Promenade in this region is in a state of disrepair, with areas experiencing significant deterioration and loss of retained earth, leading to the formation of sinkholes on the Promenade walking surface.**

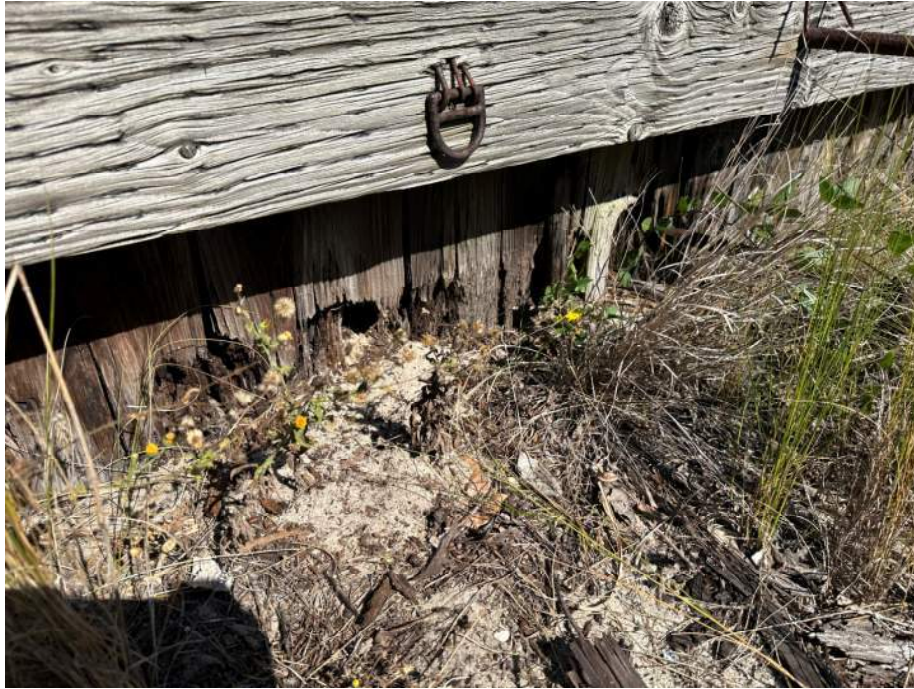
Photo #17 - Failing timber bulkhead on south side of the promenade on the West End.

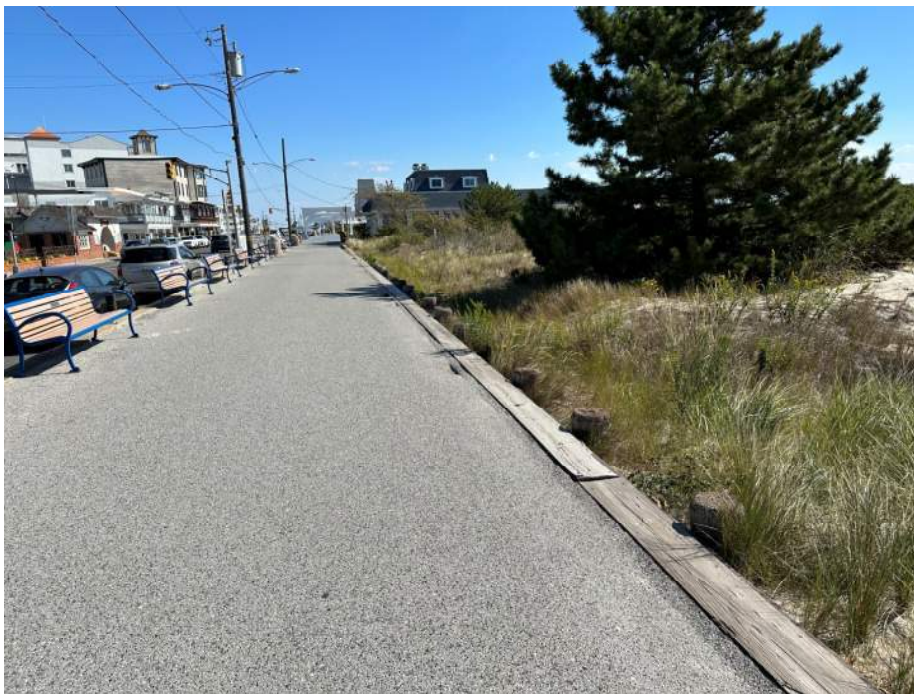
Photo #18 - Settlement behind failing timber bulkhead.

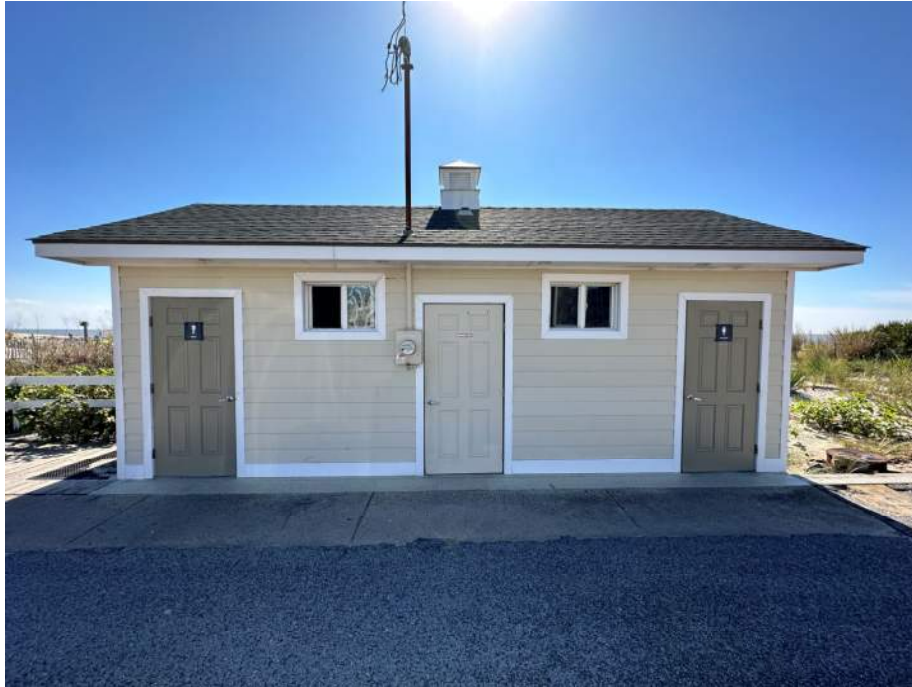
Photo #19 – Gratn St Comfort Station.

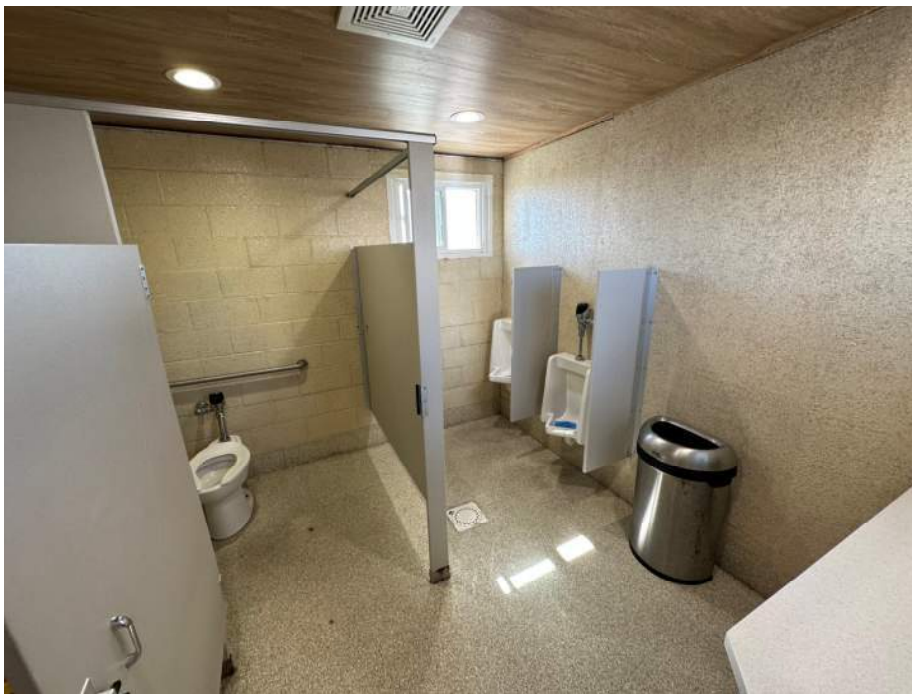
Photo #20 – Inside Grant St comfort station.

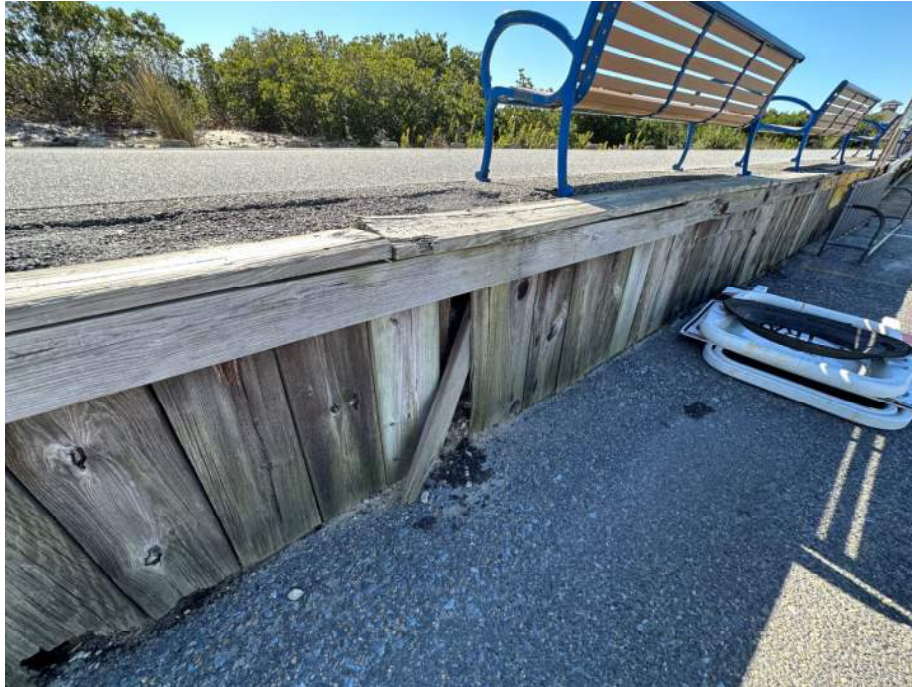
Photo #21 – Failing timber bulkhead on along Beach Avenue.

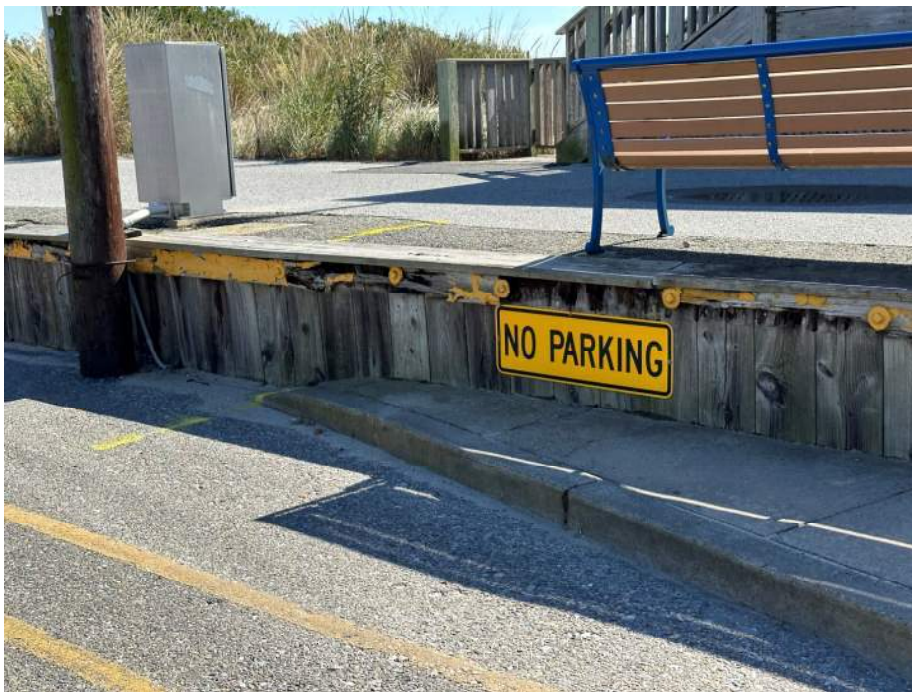
Photo #22 – Failing timber bulkhead along Beach Avenue.
